Underwater archaeological investigations of a shipwreck near the Eemshaven, municipality Eemsmond, (Gr.)

ARC-Publicaties 152

2006

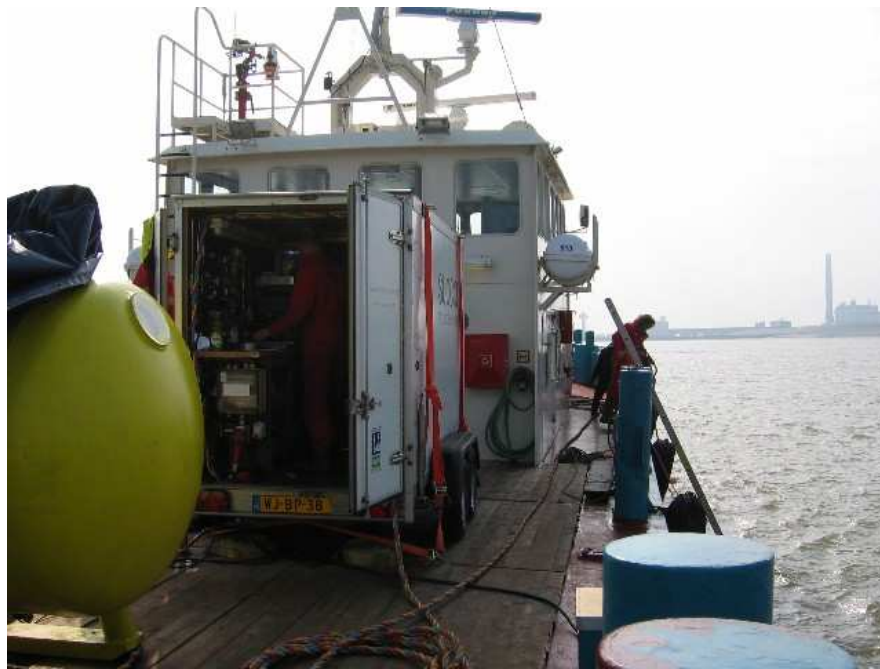
Figure 2.1 Locations of D1. Photo: C.G. Koopstra.

On location D1 (fig. 2.1), the divers of Subcom discovered wooden parts of a shipwreck (see details in Subcom report).¹ These wooden remains include large planks from the hull of the ship as well as beams. On these planks mortice and tenon joints are visible. Smaller planks probably belong to a deck. A large round beam that protrudes from the soil might be a mast. Two samples were taken from the planks, in order to obtain a dendrochronological date of the wood. Three loose finds were also collected, a human bone, a pointed stick and a rounded, eroded tenon.

The large measurements of the planks and beams (Dutch: *spanten*) indicate that the ship was of a considerable size. The actual size of the vessel cannot be determined, because most of it is still covered with clay, but it is possibly up to 30 m long. The hull of the ship has a smooth surface, with narrow seams between the planks. The dendrochronological samples indicate that the ship was built after 1667 AD (table 2.1). The wood originates from Niedersachsen, Germany, subregion Mittelniedersachsiges Tiefland.

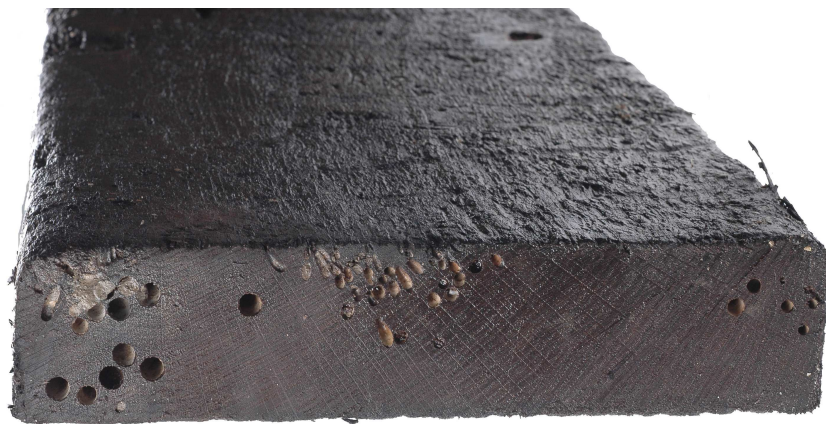
Figure 3.1 The rounded edge of the plank, ARC findsnumber 2. Photo: L. de Jong.

This is a sample from a larger plank, and sawn on the findspot. The sawn piece is 84 cm long, 28 cm wide, and 6 cm thick. The plank is dated after 1667 ± 6 AD (table 2.1). The wood species is oak (*Quercus*). The transverse section of oak is characterized by broad rays and ring-porousness with a flamelike pattern. The

The plank is sawn 'en dosse', which means that on the serrated edge, the year-rings show at an angle. One of the edges of the plank is rounded. This indicates that this side did not join up other woodwork (fig. 3.1). At the transverse section the wood is affected by shipworm (*Teredinidae*) and angel wing or white piddock (fam. *Pholadidae*, *Parnea candida* sp.).

Two samples of planks were sawn from the shipwreck near the Eemshaven. Because they are rounded on one side, they appear to belong to an end of a construction. The samples probably represent parts of the gangway.

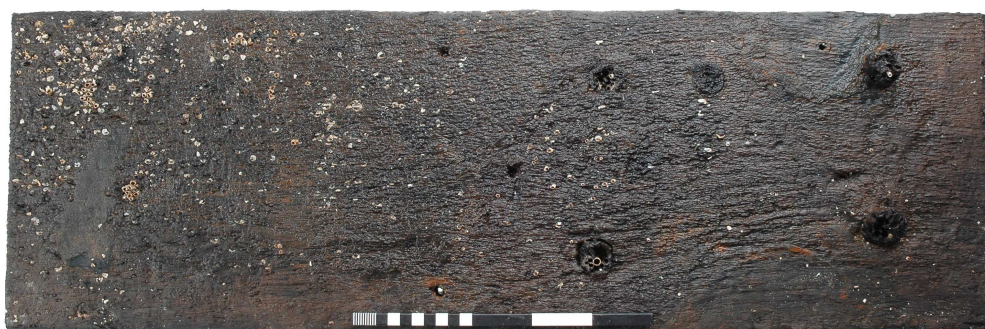
Figure 3.2 The wooden pegs in the plank and the nailholes, just above the measuring scale. Photo: L. de Jong.

In the plank there are remains of five oak tenons (Dutch: *toognagels*), 3 cm in diameter (fig. 3.2). The wooden tenons are fixed with square pegs. On the inner side of the plank the tenons protrude, on the outside they are neatly smoothed with the surface of the plank (fig. 3.3). On the inside the plank was attached to another piece of wood. There remains at least about 50 cm of the sampled plank, to the left of the tenons (cf. fig. 3.2). This indicates that this plank probably is part of the gangway, rather than from the hull of the ship. For if it were a part of the hull, the tenons would be placed at a closer distance, within 50 cm, to join the hull

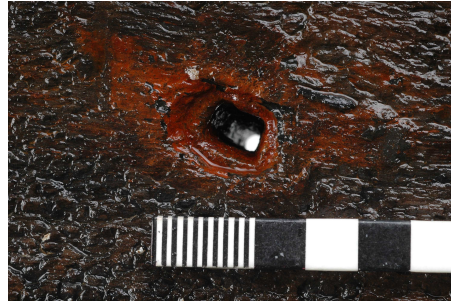
Figure 3.4 The imprint of the head of the wrought iron nails. Photo: L. de Jong.

Apart from the tenons, there are three nailholes visible. The nails are hit through the plank from the outside towards the inside. The imprints of the nails are clearly visible (fig. 3.4). Welded nails with a square or slightly rectangular section were used.

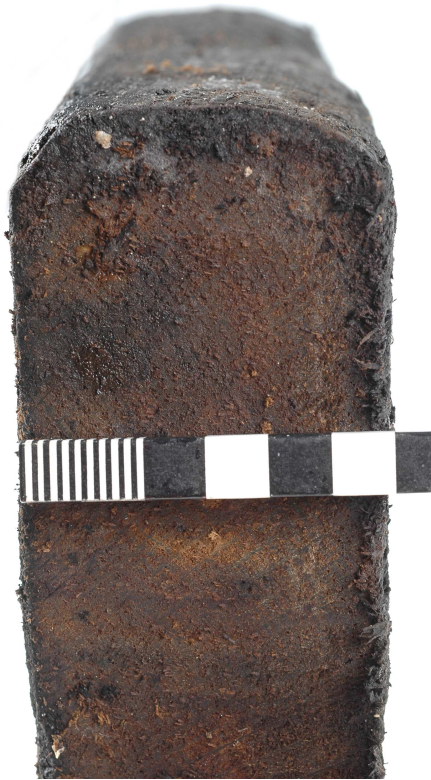
Figure 3.5 The two rounded edges of the plank, ARC findsnumber 7. Photo: L. de Jong.

This sample measures 34×30×6 cm. On the transverse section it is affected by shipworm and/or angel wing. The plank is made of oak. It has two rounded edges, which indicates that this side of the plank did not join up other woodwork (fig. 3.5). In the plank an oak tenon is constructed (fig. 3.6). Comparable to the sample of findsnumber 2, this tenon protrudes on the inside of the plank. At the outside it is neatly smoothed with the surface of the plank. This plank is made of a tree that was felled after 1656 ± 6 AD (table 2.1).

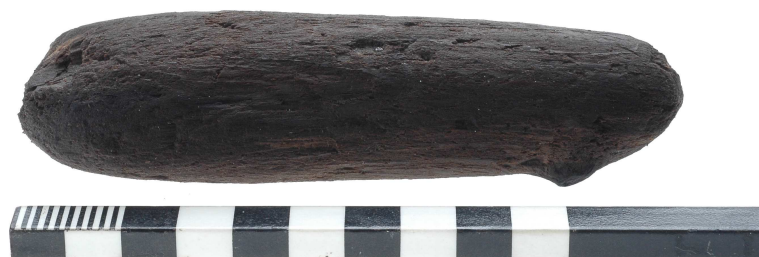
Figure 3.7 The possible wooden tenon, ARC findsnumber 5. Photo: L. de Jong.

Findsnumber 5 is presumably a tenon, and it is made of oak. The length is 12 cm and the section is oval, 3 by 4 cm. This piece is very weathered and rounded, very likely by tidal currents (fig. 3.7). So originally it may have had a different shape and function, and the assumption that the object is a tenon, might be incorrect.

An eroded and rounded piece of wood possibly represents a wooden tenon, belonging to a mortice and tenon joint from one of the planks of the ship. The pointed piece of roundwood was taken from another location and has no connection to the shipwreck.

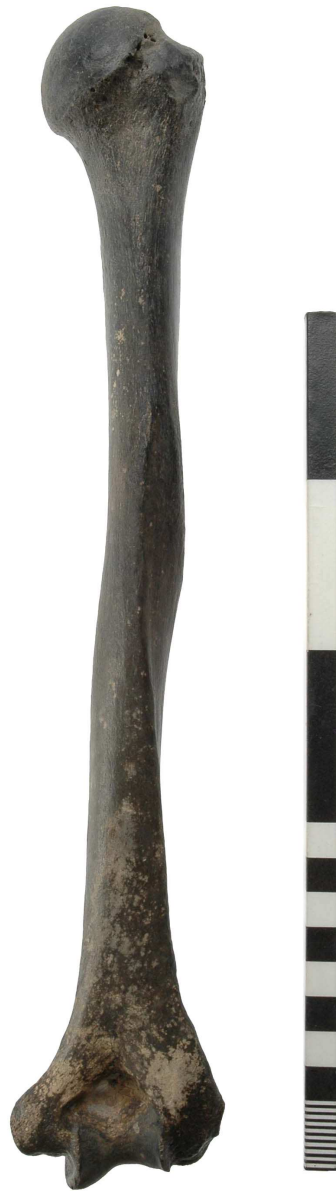
Figure 4.1 Human humerus, posterior. Photo: L. de Jong.

The examined bone is a complete, right *humerus* (upper arm) of an adult individual (fig. 4.1). In order to keep the bone intact, it is decided not to cut a section through the bone, in order to be able to investigate the bone structure for a calculation of the age. Another useful indication for the age of the individual is the fact that at the location where the *diaphyse* fuses with the *epiphyse*, for some years a line of growth can be observed. Because this line of growth is absent on this particular bone, it indicates that the individual was certainly over thirty years old.

The posterior side of the head of the humerus, shows signs of eburnation. Eburnation occurs when the cartilage is afflicted, which causes the joints to grate directly over each other. This leads to a polishing of the bone surface. In combination with porosity, eburnation is a result of degenerative arthritis.

The studied bone is a right humerus from an adult individual. The context of the find, together with morphological indications, suggest it belonged to a male individual. Considering the long stay in saltish water, the bone is very well preserved.

For two reasons, the age of the person cannot be determined. On the one hand the humerus would have to be cut into halves to take measurements for age-determination. On the other hand there are no other parts of the skeleton present for extra indications for the estimation of the age. The length of the individual, in the case of being male, might be $174,6 \pm 4,05$ cm. The humerus shows eburnation, caused by degenerative arthritis.

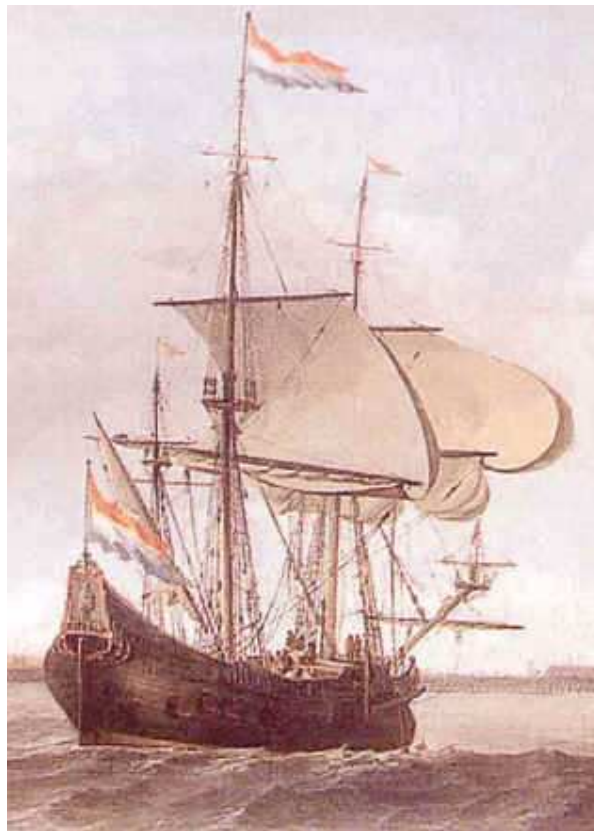
Figure 5.1 Fluitschip, ca. 1650. Painting: J.Th. Blankenhoff.

Types of ships that were much used for trade with the Baltic in the 17th century include *fluit*, *katschip*, *smak*, *galjoot* and *bootschip*. The *fluit* was one of the most common trading ships in Europe. These *fluiten* (flutes) were pear-shaped, narrow and long (fig. 5.1). Because of this construction, the *fluiten* had a relative small main deck, measuring approximately 35–40×5.5 m. In this way high taxes could be avoided, which were imposed by Denmark in the Oresund, and which were calculated per square meter of the main deck.
